TEST REPORT

Report No. : 25-000354-01-2

Description : SMART POSITIONER

Model Name : YT-3350

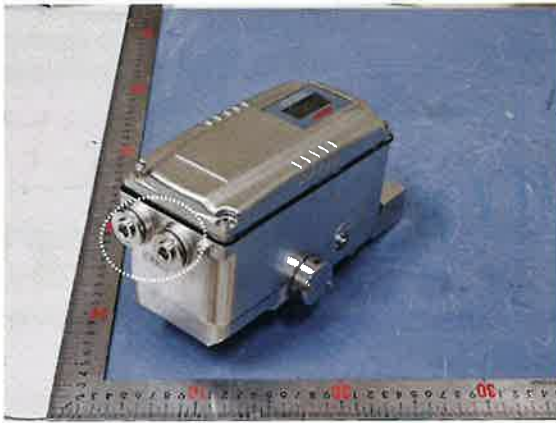
[Fig. 1: Sample]

- Description : SMART POSITIONER
- Model Name : YT-3350
- Dimensions : 242.5 mm × 93.5 mm × 144.0 mm

The cable entry was assembled with the plug (Refer to Fig. 1)

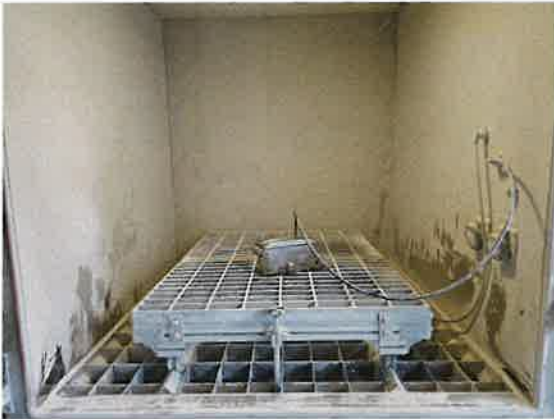
[Fig. 3: IP6X]

Code Letters	IP	Conditions & Results
1st Characteristic numerals Against ingress of solid foreign objects	6	2.1 Dust Test Conditions (Category 1) <ul style="list-style-type: none"> Amount of talcum powder in the test chamber: 2 kg/m³ * Talcum powder: Pass through a square-meshed sieve (wire diameter: 50 μm, gap of wire: 75 μm) Internal free volume of the sample: 1 200 cm³ Depression of sample: - 2.00 kPa Extraction flow rate: About 0.01 L/min Extraction rate of volume per hour: About 0.5 Test duration: 8 h

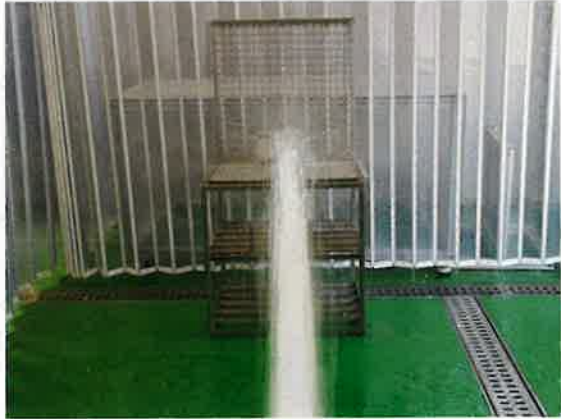
[Fig. 4: IPX6]

2.2 Dust Test Result <ul style="list-style-type: none"> Pass
2nd Characteristic numerals Against ingress of water with harmful effects	6	2.3 Water Test Conditions <ul style="list-style-type: none"> Internal diameter of the nozzle: 12.5 mm Delivery rate: (100 ± 5) L/min Core of the substantial stream: Circle of 120 mm diameter at 2.5 m distance from the nozzle Distance from nozzle to enclosure surface: (2.5 ~ 3.0) m Test duration: 3 min

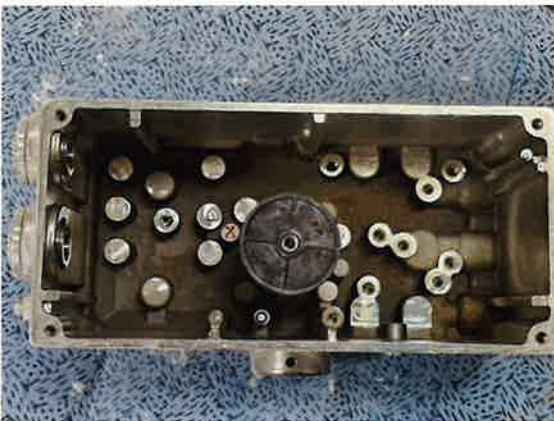
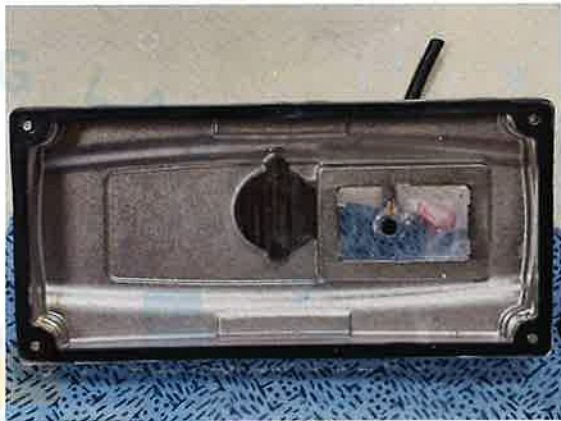
5. Dust Test Result Figures
